Paint Failure Blues

Indoor air quality (IAQ) problems occur inside a building for a number of reasons that include the presence of mold as well as a food chain, with mites at the bottom and spiders at the top (all these living organisms produce allergenic fecal matter). Microbial growth (mold, yeast, bacteria), as well as a host of creatures, including mites, carpet beetles and other spider prey, require moisture for growth. As an IAQ professional, therefore, I am always concerned about moisture problems in buildings.

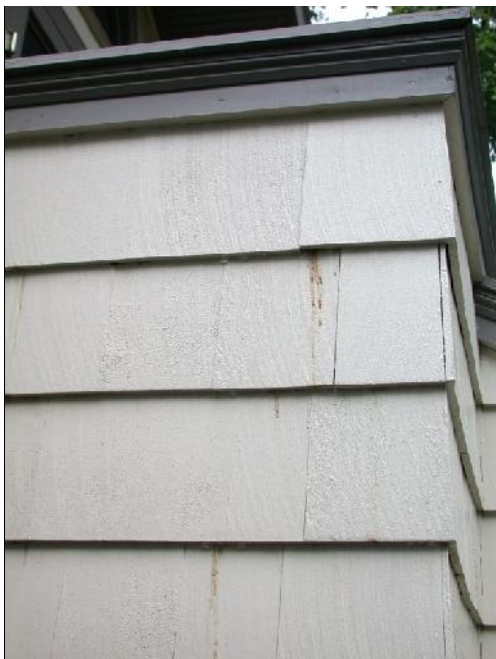
Cedar-extractive stains
May Indoor Air Investigations LLC

When I see signs of roof-water splash, improper grading, malfunctioning gutter systems, cedar-extract staining, and improperly sloped flashings, I worry before I even enter the building.

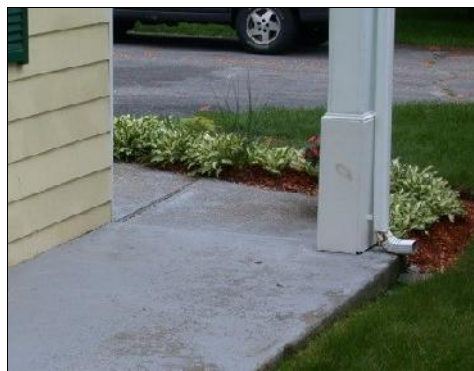
Whoops!
May Indoor Air Investigations LLC

In the photograph above, the elbow joint is reversed and leaked. The pitch at the concrete slab was also reversed, and roof water soaked into the wood structure. There was extensive termite damage present.

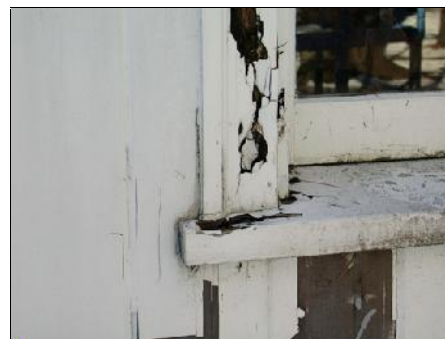
Peeling paint and decay resulting from incorrectly sloped window-cap flashing
May Indoor Air Investigations LLC

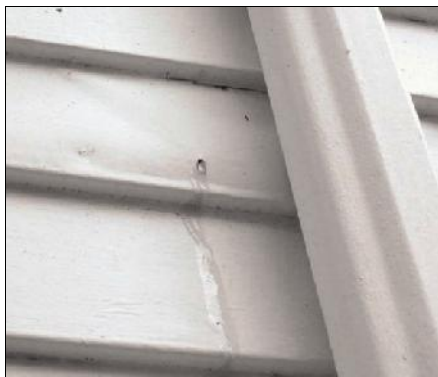
Water leaking from a paint blister
May Indoor Air Investigations LLC

When moisture accumulates behind the paint film faster than it can diffuse out through the film, an actual blister of water can form in young, flexible paint films.

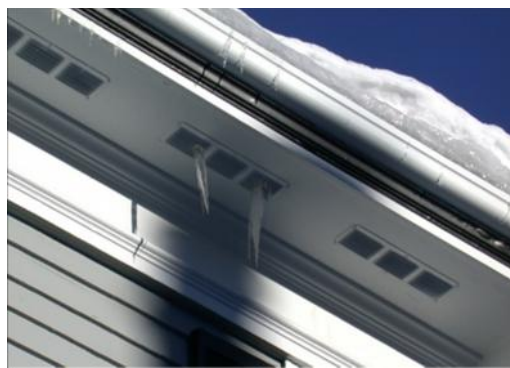
Ice dam water in soffit
May Indoor Air Investigations LLC

A single occurrence of ice damming can cause clapboards swelling sufficient to result in severe failure in a thick, old paint film.

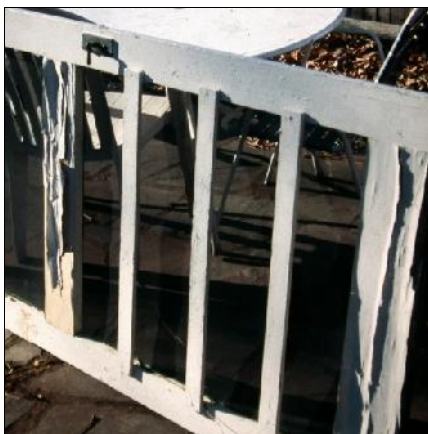
Paint peeling from a screen door
May Indoor Air Investigations LLC

The screen door above from a covered Victorian porch was one hundred years old and had been painted dozens of times but never exposed to rain. To refinish the front door, I removed the screen door and stored it outside in the yard. It was rained on once and much of the paint peeled off.

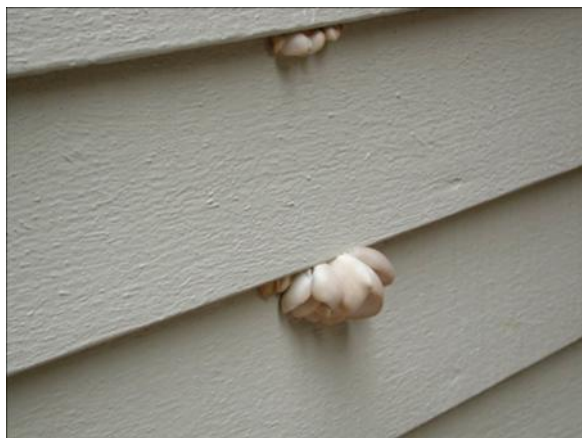
Mushroom growing out of siding due to moisture behind the cladding

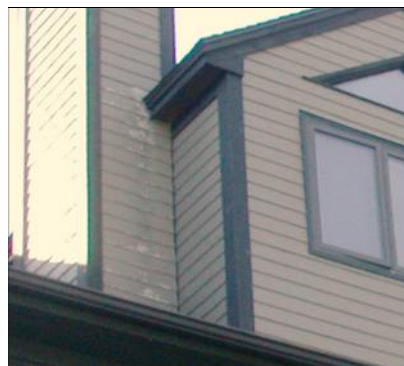
Peeling from water flow, lack of kick-out flashing

In one installation of this kind of siding, kick-out flashings were missing, so water from roof edges streamed down the cladding. As a result, the factory-applied paint failed under the roof

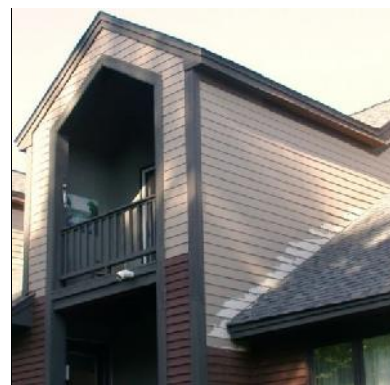
Another problem with this particular installation was that the angle-cut ends of the planks at the dormers on the gable roof were almost in contact with the roof shingles. These cut ends absorbed water, and all the paint peeled from the cement boards at the bottoms of the dormer walls. (The installation manuals now require a two-inch rather than a one-inch clearance to roof shingles.)

Cement-board siding, peeling shingles

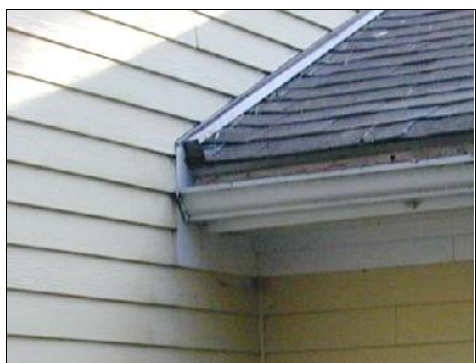
Cement-board kick-out flashing
May Indoor Air Investigations LLC

There must be kick-out flashings at roof edges that intersect with vertical walls. It would also help if manufacturers of this type of siding always back-primed the boards and sealed the butt ends and end grains. Finally, I recommend that factory-supplied sealants be applied to all cut ends, which will reduce water absorption.
